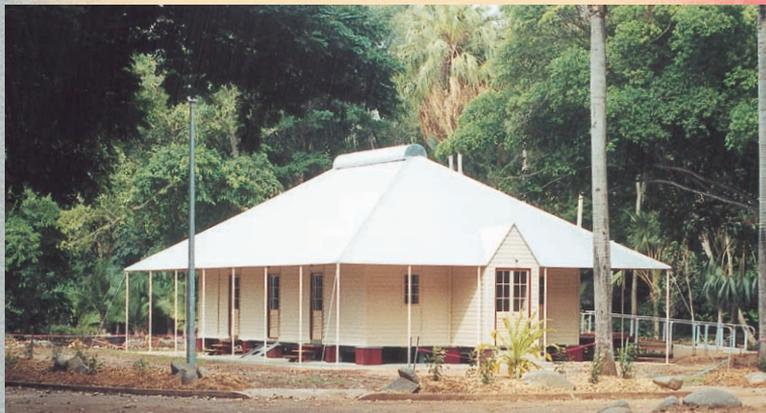
The reconstructed Church building in the Darwin Botanic Gardens

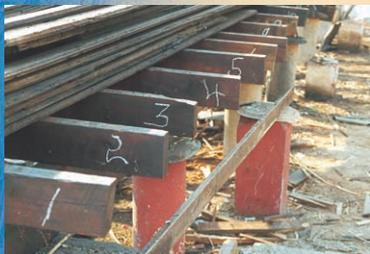
Dismantling the Wesleyan Methodist Church, 2000

The Church was carefully dismantled and all components were numbered and relocated to the Darwin Botanic Gardens. Some interesting discoveries were made as the building was dismantled - the original roof framing was considerably lighter than first thought, floor framing members had been replaced and strengthened and the floorboards had been totally destroyed by termites.

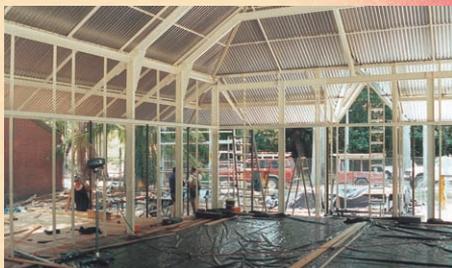
Re-erecting the Church in the Darwin Botanic Gardens, 2000

A new steel supporting frame was first erected at the Darwin Botanic Gardens and then the original steel wall and roof framing was fixed in position. Missing sections of the walls and the front entrance porch were reconstructed. Cypress Pine floor framing was reused and fixed to new concrete piers. The termite damaged flooring was replaced with new floorboards.
